VIBRATION AND SHOCK TEST REPORT

Company : Traco Electronic Co. Ltd.
Address : Jenatschstr. 1., CH-8002 ZURICH, Switzerland.
Model Name : TEP 75-2415WI
Date Received : JUN 16, 2012
Date Tested : JUN 16, 2012

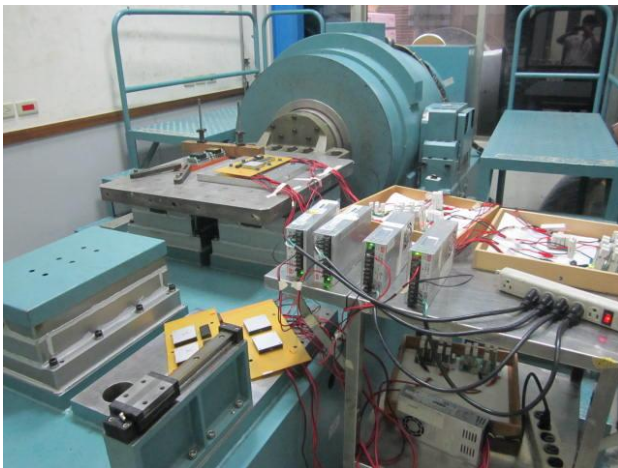
Operating

Attachment 2 : Photo of vibration and shock test setup
